UNITED STATES ENVIRONMENTAL PROTECTION AGENCY

Re: Notice of Violation
Heritage Environmental Services
EPA I.D.: IND 093 219 012

INTRODUCTION	3
FACILITY BACKGROUND	3
INVESTIGATION METHODS	4
ON-SITE INSPECTION SUMMARY	6
PROCESS OVERVIEW	6
Waste Approvals	7
Waste Acceptance, Receiving, and Tracking	8
Stabilization of Hazardous Waste	10
Dose Response Testing and Post-treatment Verification Sampling and Analysis	11
Wastewater Treatment Plant	12
Additional Treatment Processes	12
Heritage Roachdale Landfill	13
LABORATORY ACTIVITIES SUMMARY	15
SAMPLE RECEIPT AND ANALYSIS	15
ANALYTICAL PROCEDURES AND ANALYSTS	15
ANALYTICAL RESULTS	16
DATA QUALITY SUMMARY	18
SUMMARY OF OBSERVATIONS	20
KEY OBSERVATIONS	20
AREAS OF CONCERN	20
TABLES	
1 Laboratory Sample Delivery, Receipt, and Transfer	15
2 Analytical Procedures and Analysts	15
3 Laboratory Analytical Results Results for 14 Metal Constituents Covered by Universal Treatment Standards	17
4 Laboratory Analytical Results for Six Analytes Not Covered by Universal Treatment Standards	18
FIGURE	
1 Dose Response Testing Flow Diagram	9

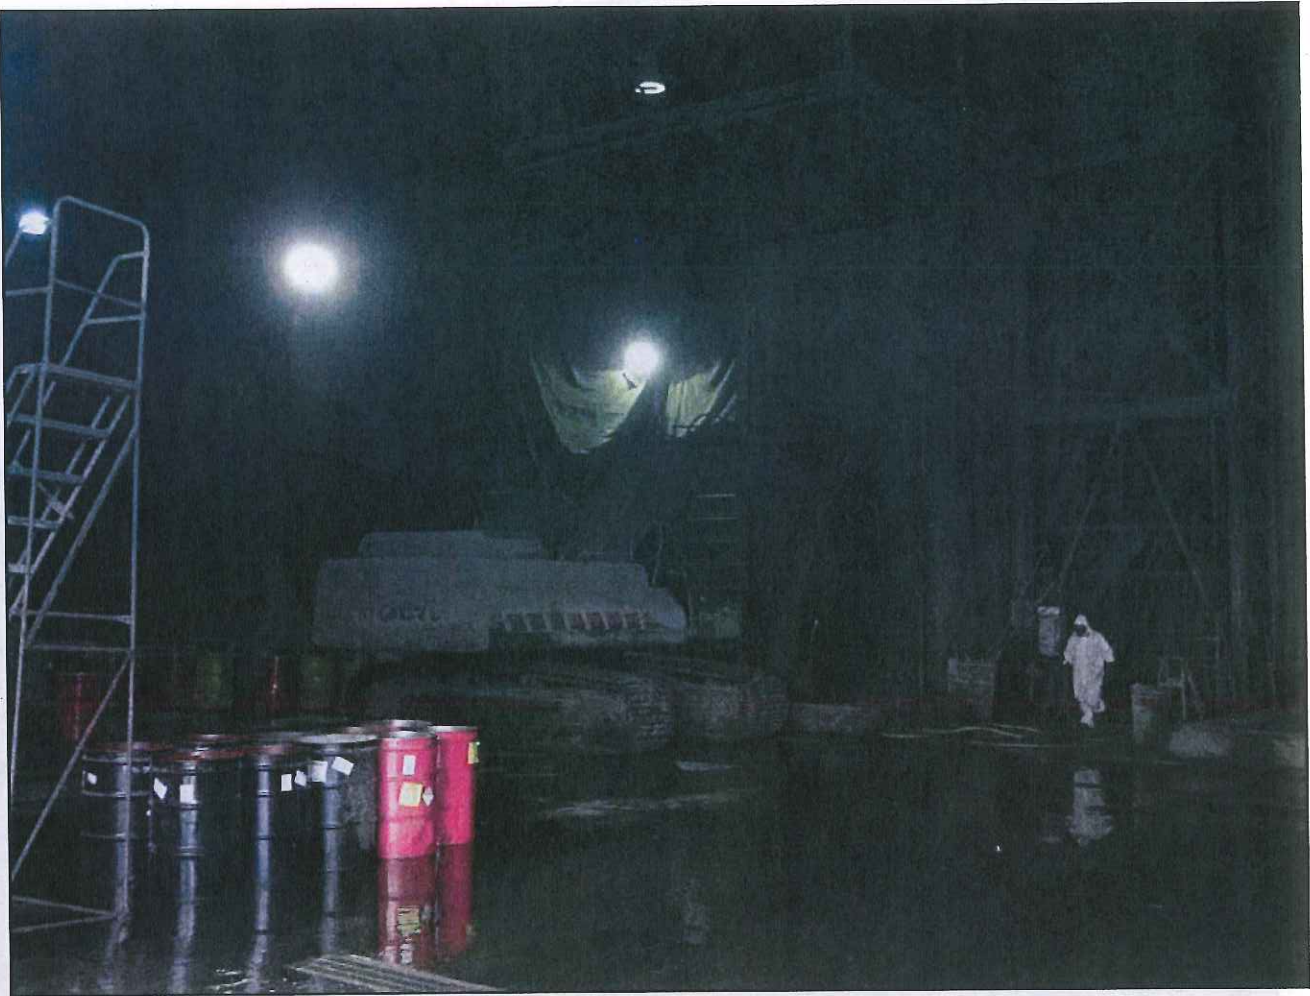
Attributes	
File Name	RIMG0060.JPG
Date Time Stamp	7/20/2012 10:55:45 AM
Photographer:	A. Ruhs
Latitude	
Longitude	
Photo Direction	
Description:	Close-up on DF-2.

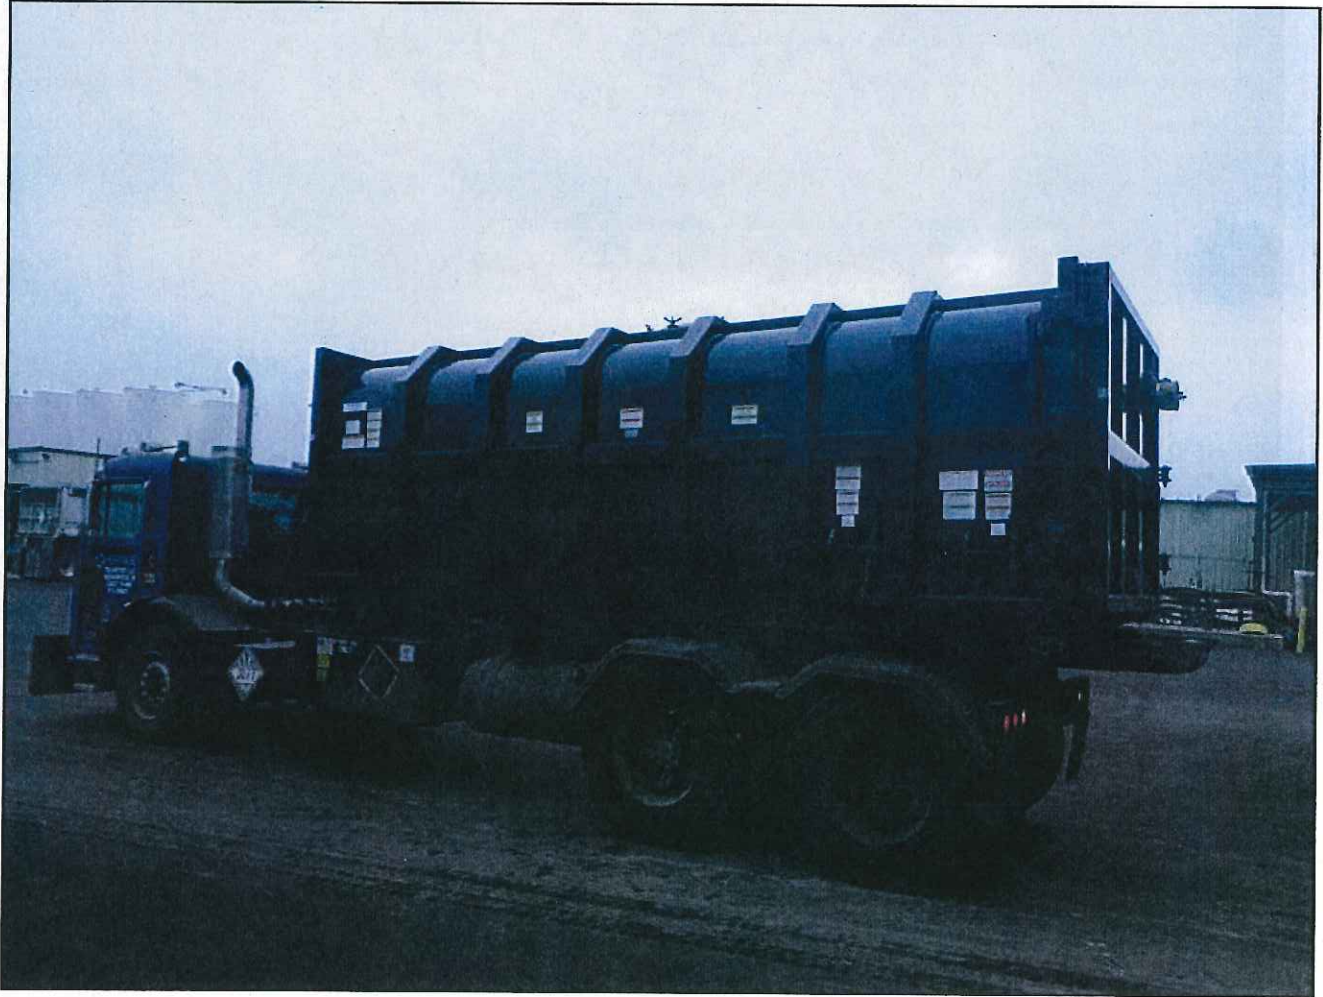
Attributes	
File Name	RIMG0061.JPG
Date Time Stamp	7/20/2012 10:58:21 AM
Photographer:	A. Ruhs
Latitude	N 39° 44' 58"
Longitude	W 86° 18' 02"
Photo Direction	68° ENE
Description:	TOSCO waste truck waiting to unload at CB-W DF-1.

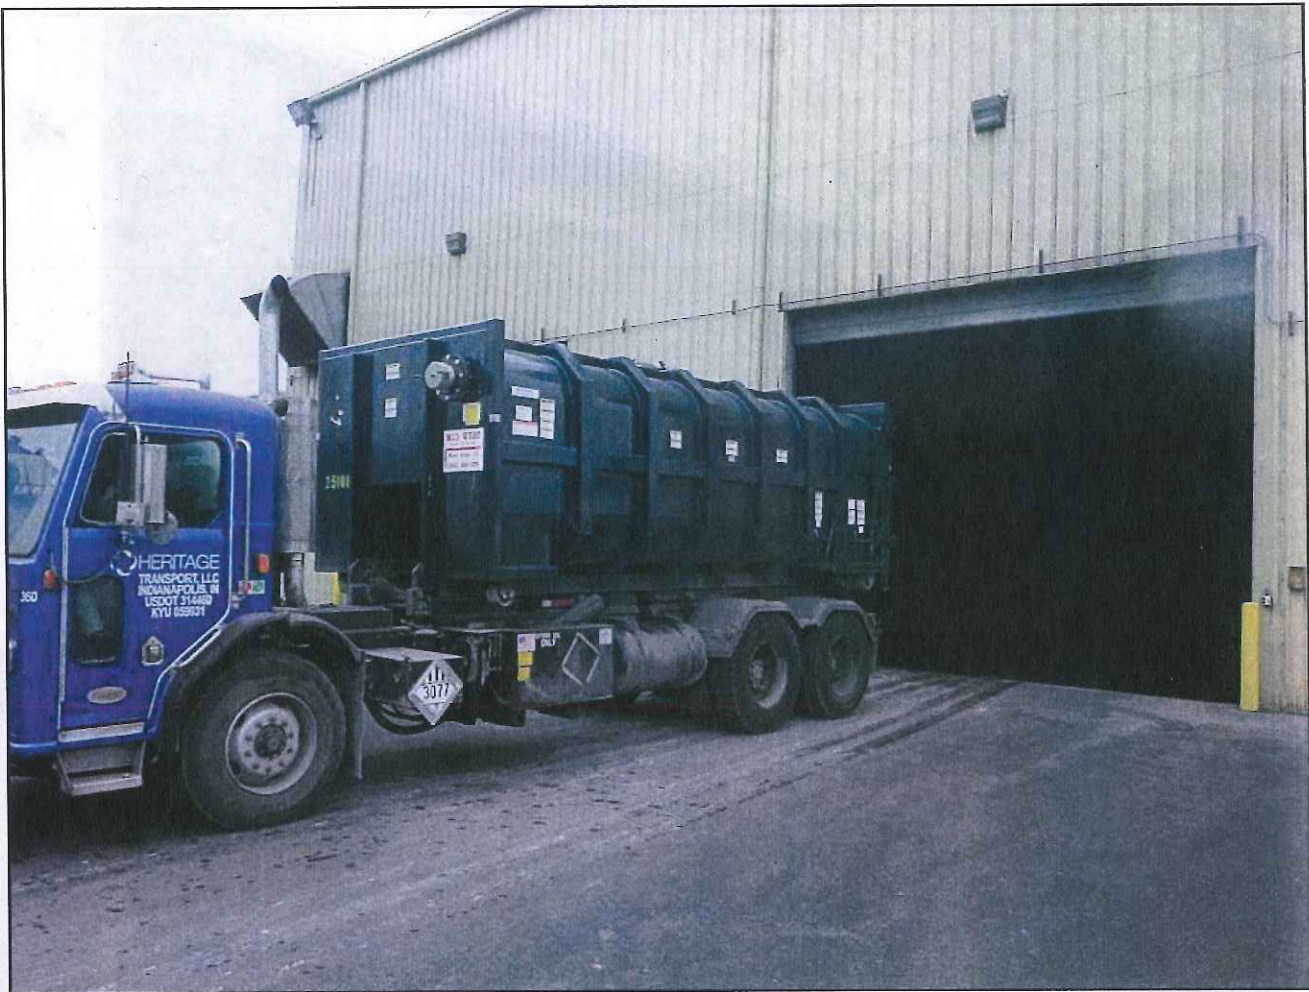
Attributes	
File Name	RIMG0062.JPG
Date Time Stamp	7/20/2012 11:01:02 AM
Photographer:	A. Ruhs
Latitude	N 39° 44' 48"
Longitude	W 86° 18' 04"
Photo Direction	168° SSE
Description:	TOSCO waste truck waiting to unload at CB-W DF-1.

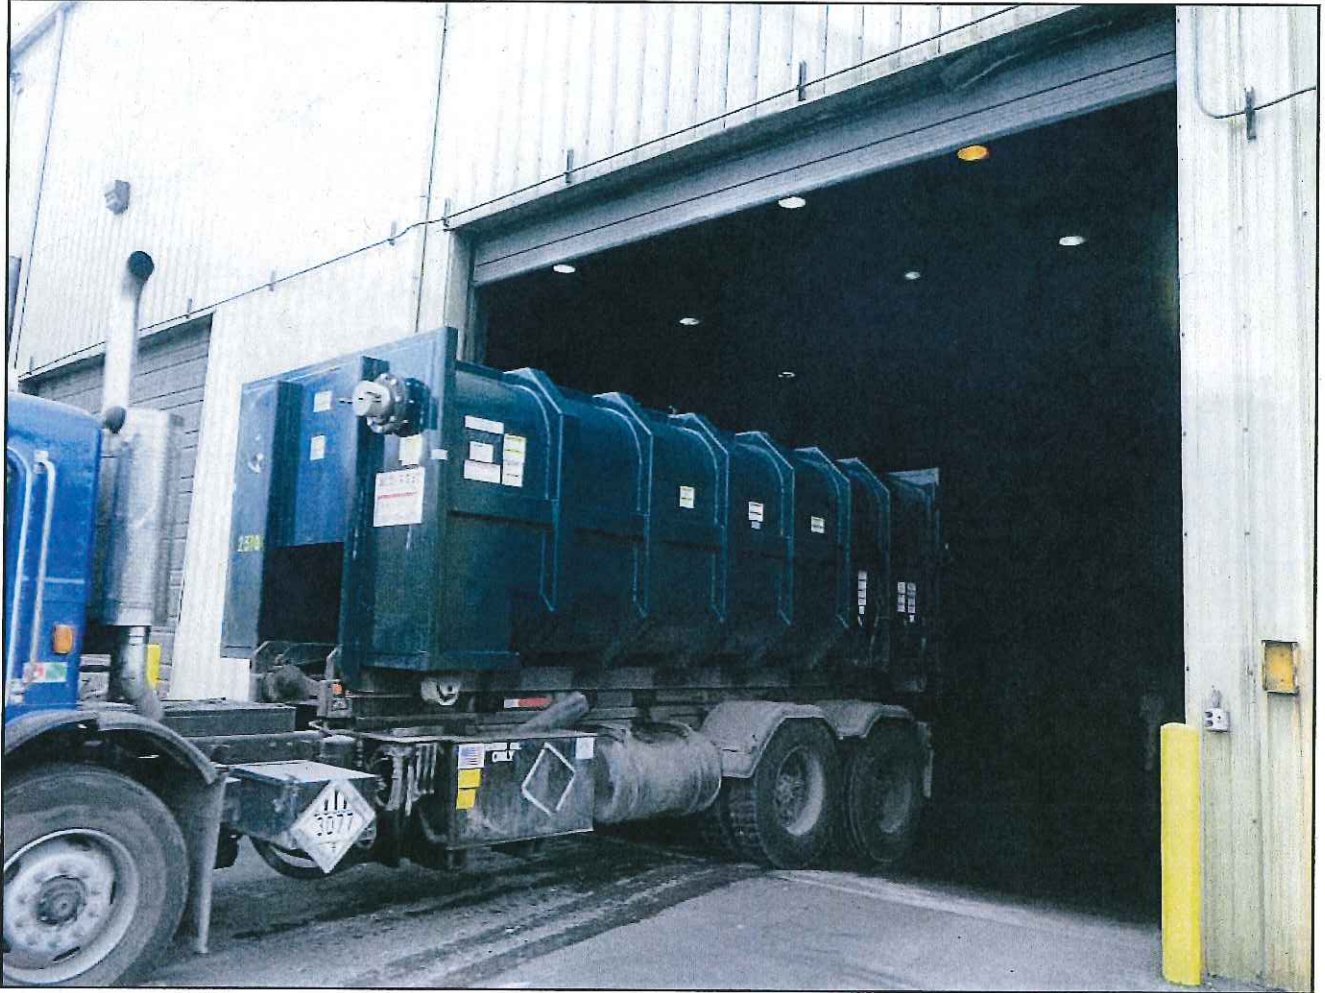
Attributes	
File Name	RIMG0063.JPG
Date Time Stamp	7/20/2012 11:03:08 AM
Photographer:	A. Ruhs
Latitude	N 39° 44' 48"
Longitude	W 86° 18' 04"
Photo Direction	164° SSE
Description:	TOSCO waste truck waiting to unload at CB-W DF-1.

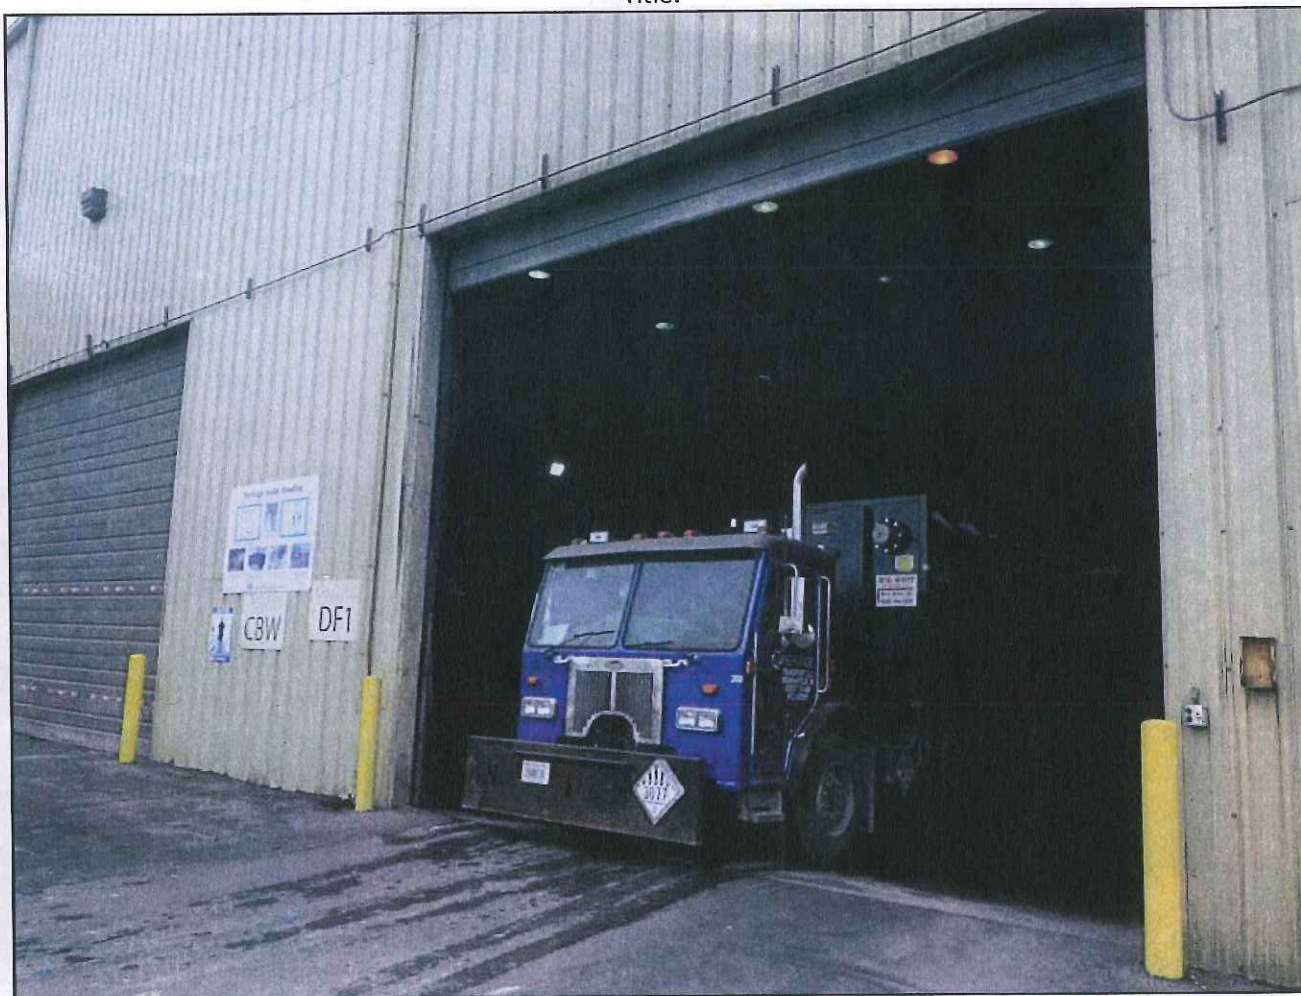
File Name	RIMG0064.JPG
Date Time Stamp	7/20/2012 11:03:13 AM
Photographer:	A. Ruhs
Latitude	N 39° 44' 48"
Longitude	W 86° 18' 04"
Photo Direction	168° SSE
Description:	TOSCO waste truck waiting to unload at CB-W DF-1.

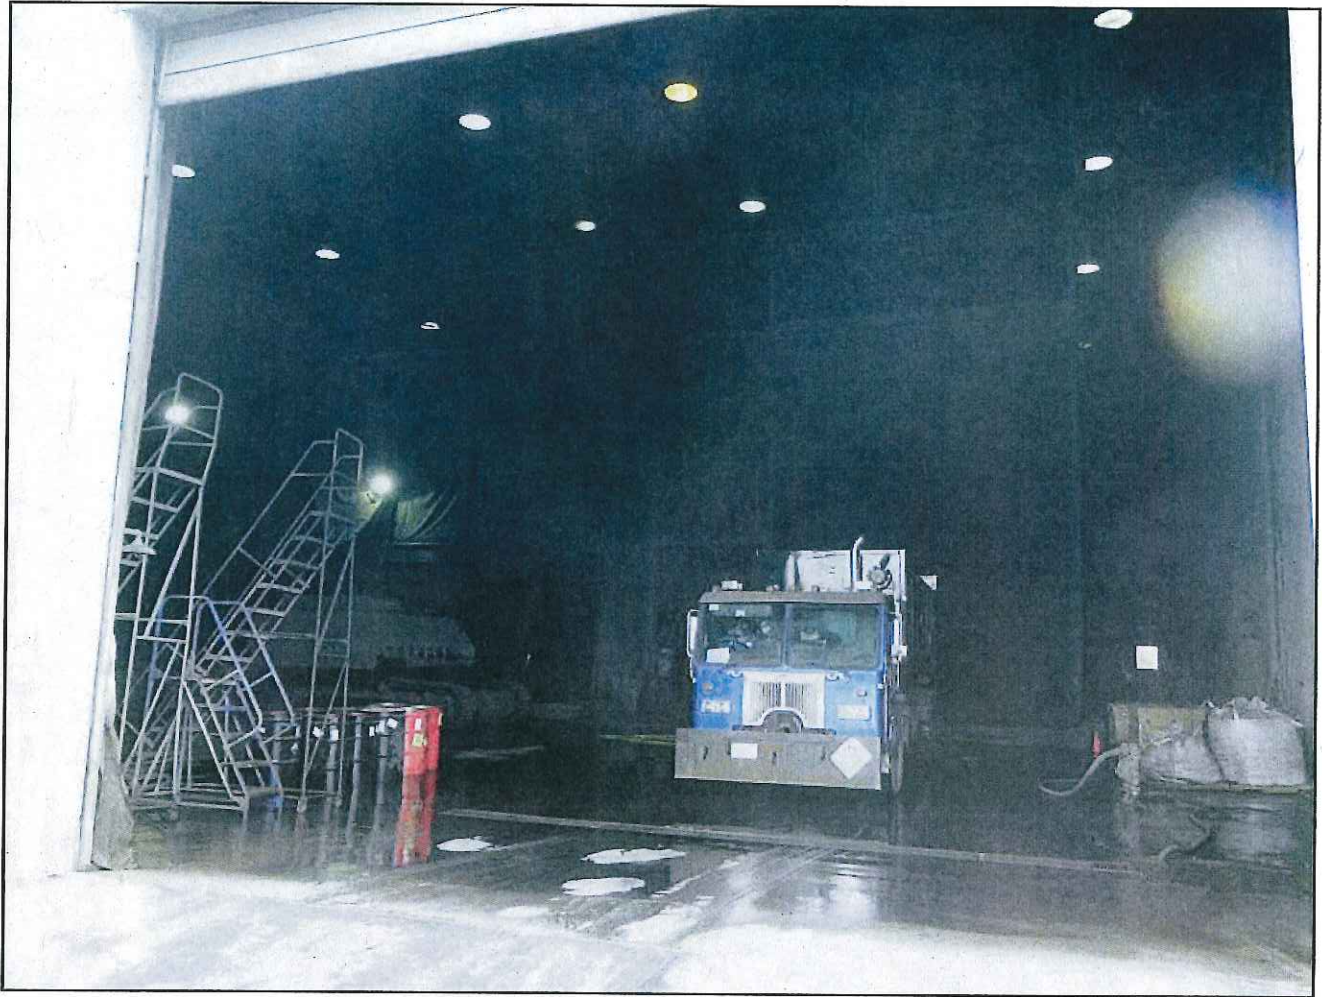
Attributes	
File Name	RIMG0065.JPG
Date Time Stamp	7/20/2012 11:03:23 AM
Photographer:	A. Ruhs
Latitude	N 39° 44' 48"
Longitude	W 86° 18' 04"
Photo Direction	182° S
Description:	TOSCO waste truck waiting to unload at CB-W DF-1.

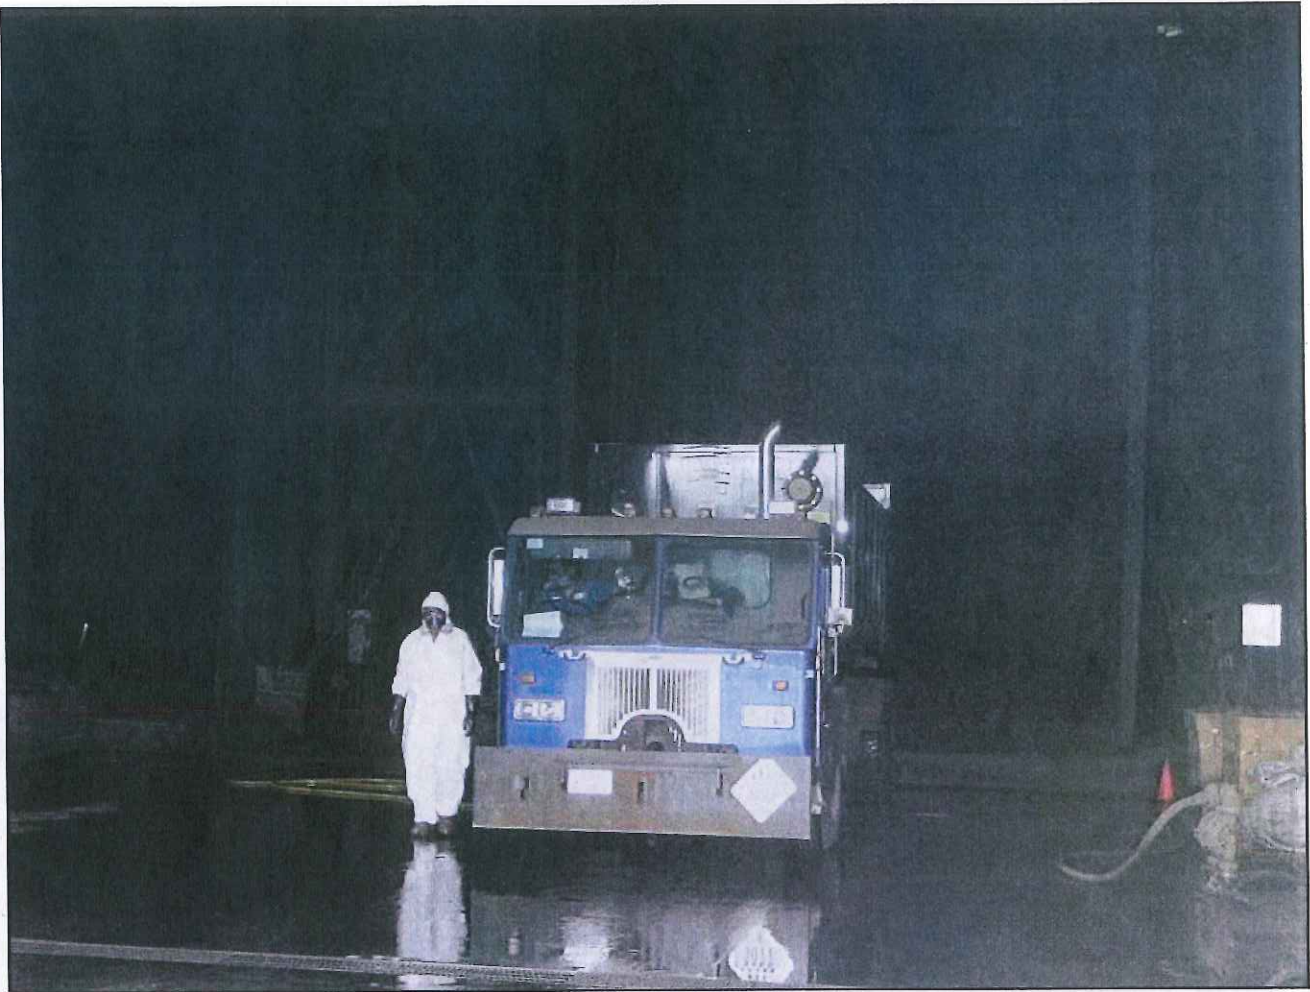
Attributes	
File Name	RIMG0066.JPG
Date Time Stamp	7/20/2012 11:03:36 AM
Photographer:	A. Ruhs
Latitude	N 39° 44' 48"
Longitude	W 86° 18' 04"
Photo Direction	189° S
Description:	TOSCO waste truck waiting to unload at CB-W DF-1.

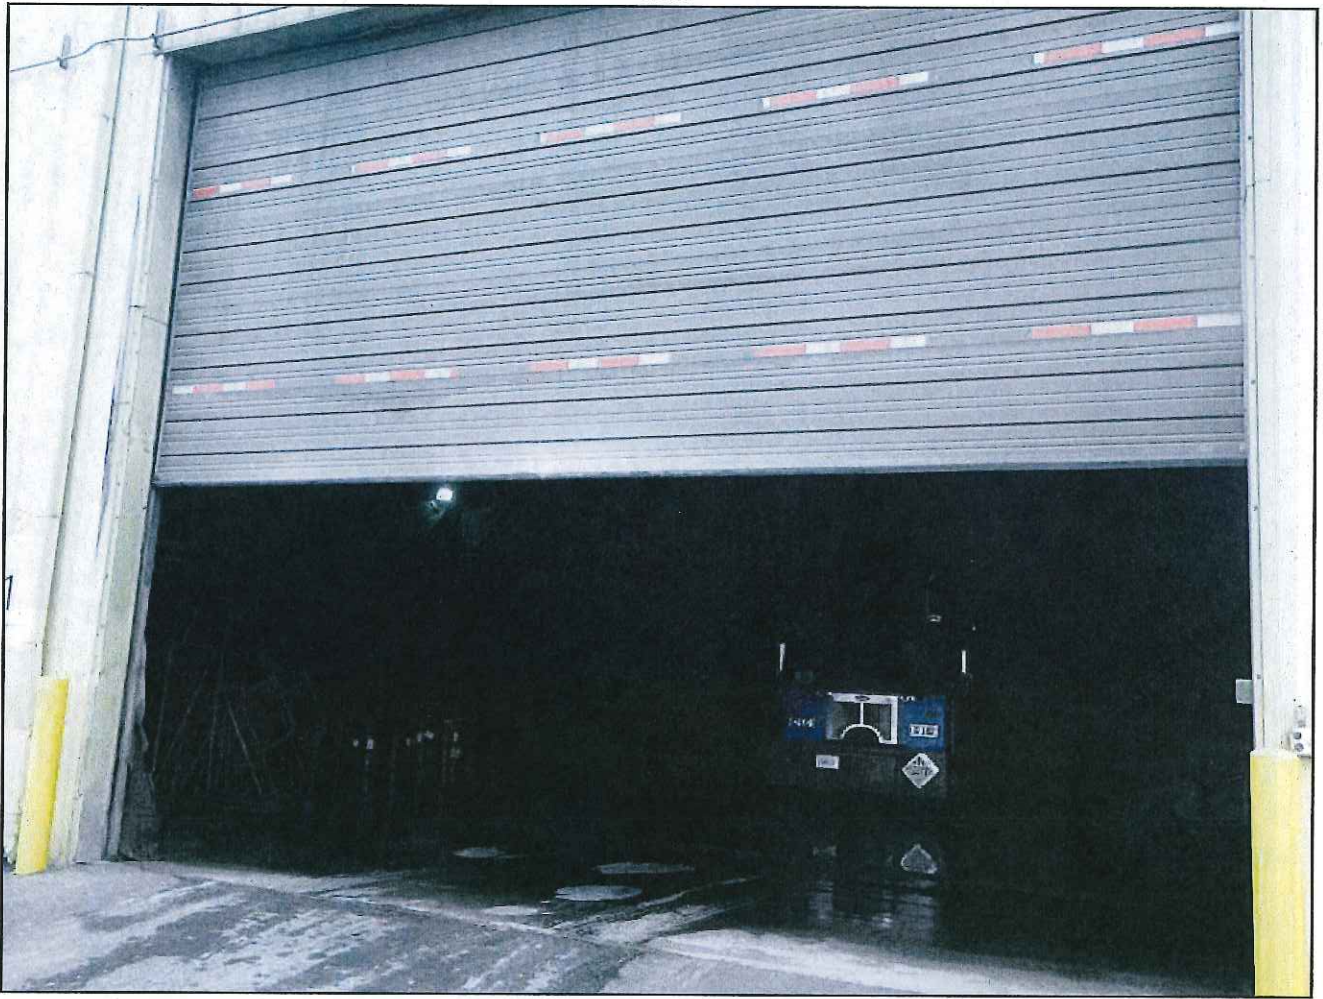
Attributes	
File Name	RIMG0067.JPG
Date Time Stamp	7/20/2012 11:04:13 AM
Photographer:	A. Ruhs
Latitude	N 39° 44' 48"
Longitude	W 86° 18' 04"
Photo Direction	180° S
Description:	TOSCO waste truck waiting to unload at CB-W DF-1.

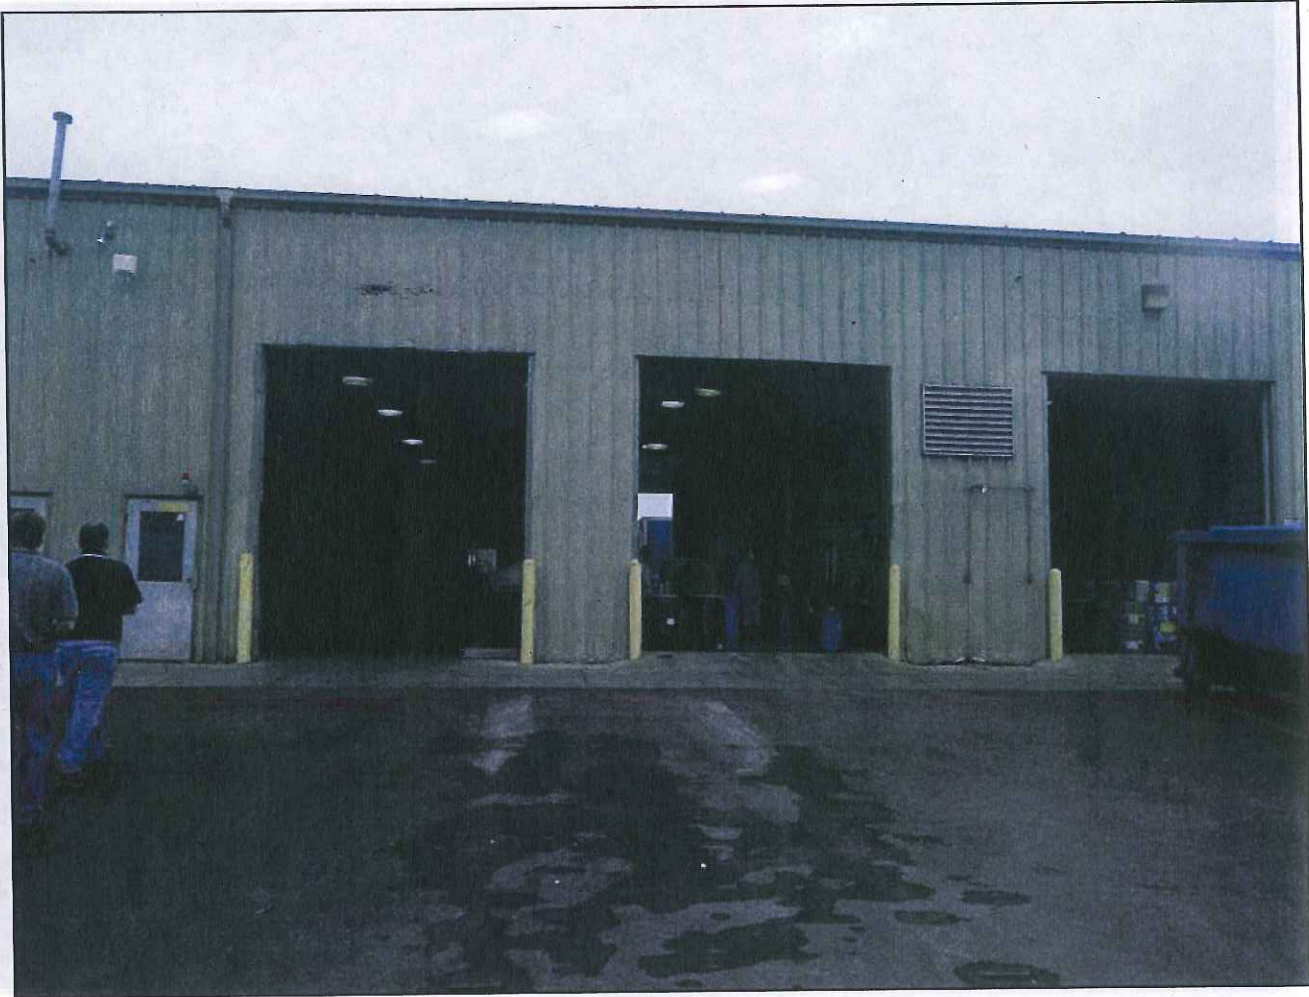
Attributes	
File Name	RIMG0068.JPG
Date Time Stamp	7/20/2012 11:07:27 AM
Photographer:	A. Ruhs
Latitude	N 39° 44' 48"
Longitude	W 86° 18' 04"
Photo Direction	347° NNW
Description:	Mercury Processing building - overview shot.

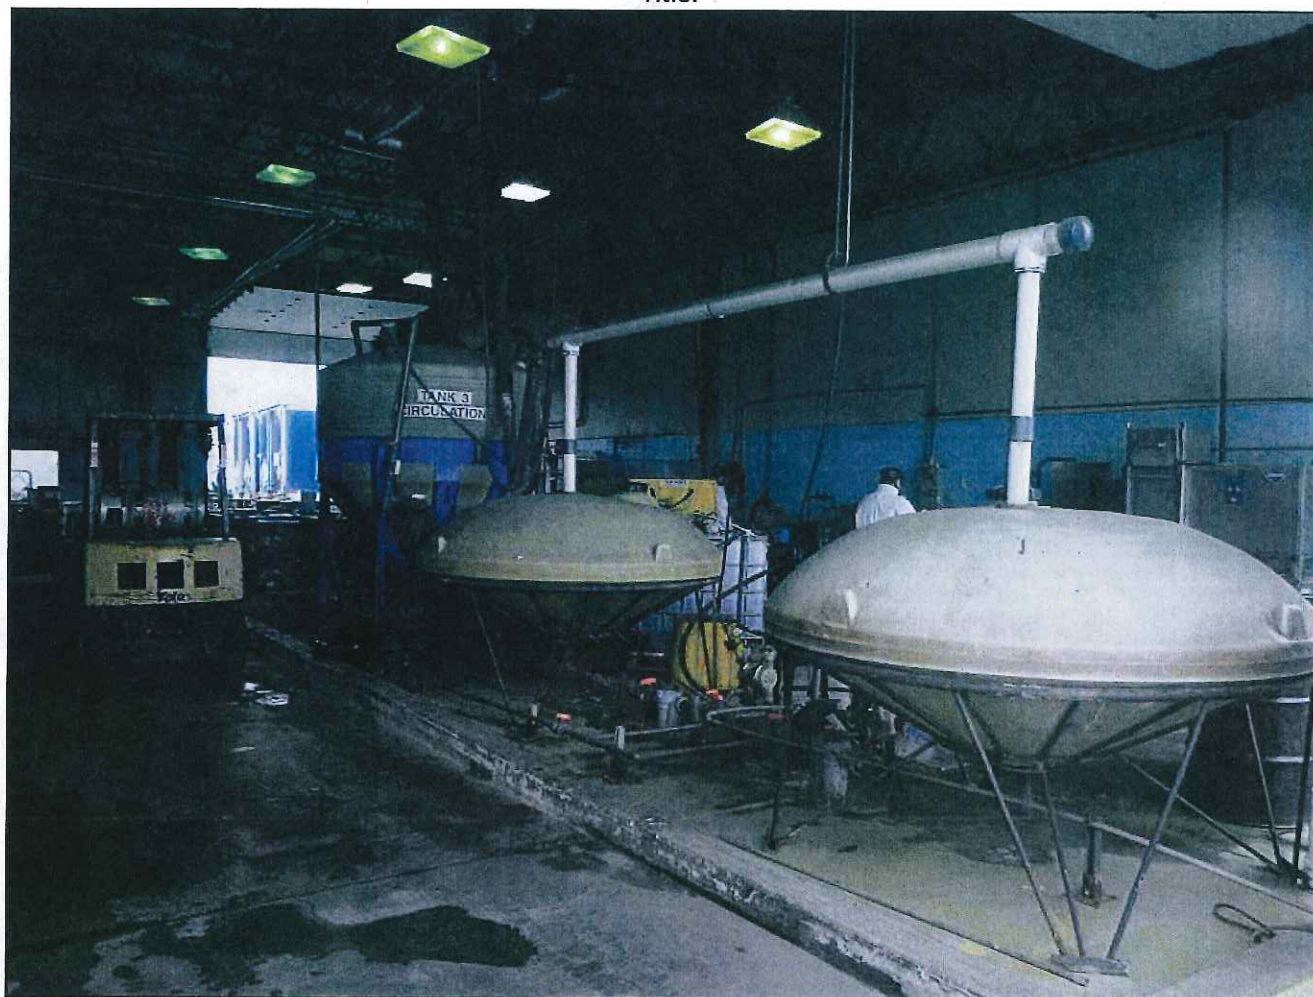
Attributes	
File Name	RIMG0069.JPG
Date Time Stamp	7/20/2012 11:07:53 AM
Photographer:	A. Ruhs
Latitude	N 39° 44' 49"
Longitude	W 86° 18' 04"
Photo Direction	15° NNE
Description:	Inside shot of the mercury processing area.

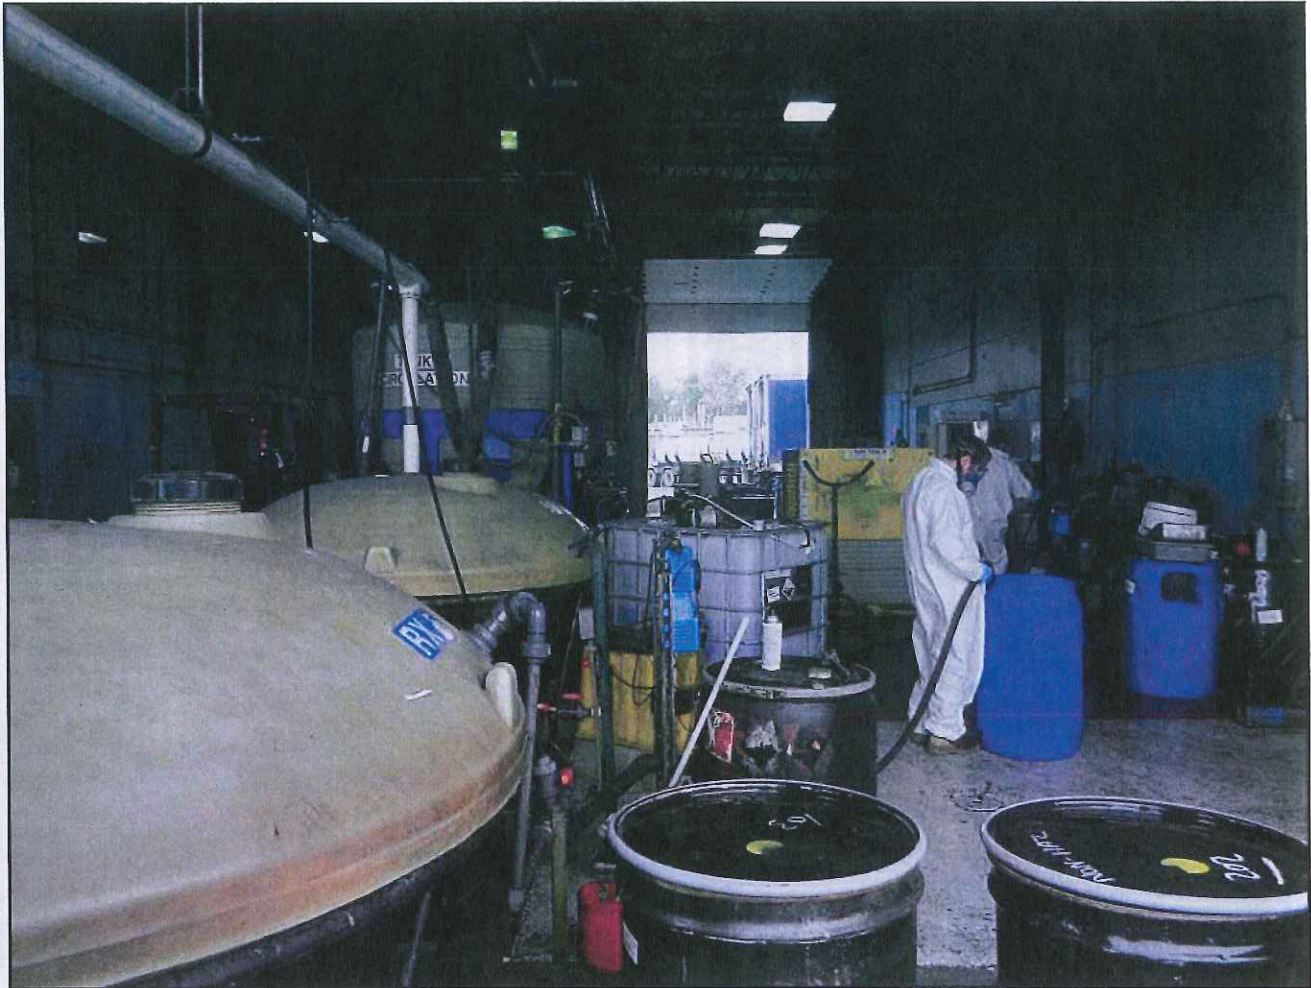
Attributes	
File Name	RIMG0070.JPG
Date Time Stamp	7/20/2012 11:18:10 AM
Photographer:	A. Ruhs
Latitude	N 39° 44' 49"
Longitude	W 86° 18' 05"
Photo Direction	351° N
Description:	Inside shot of the mercury processing area.

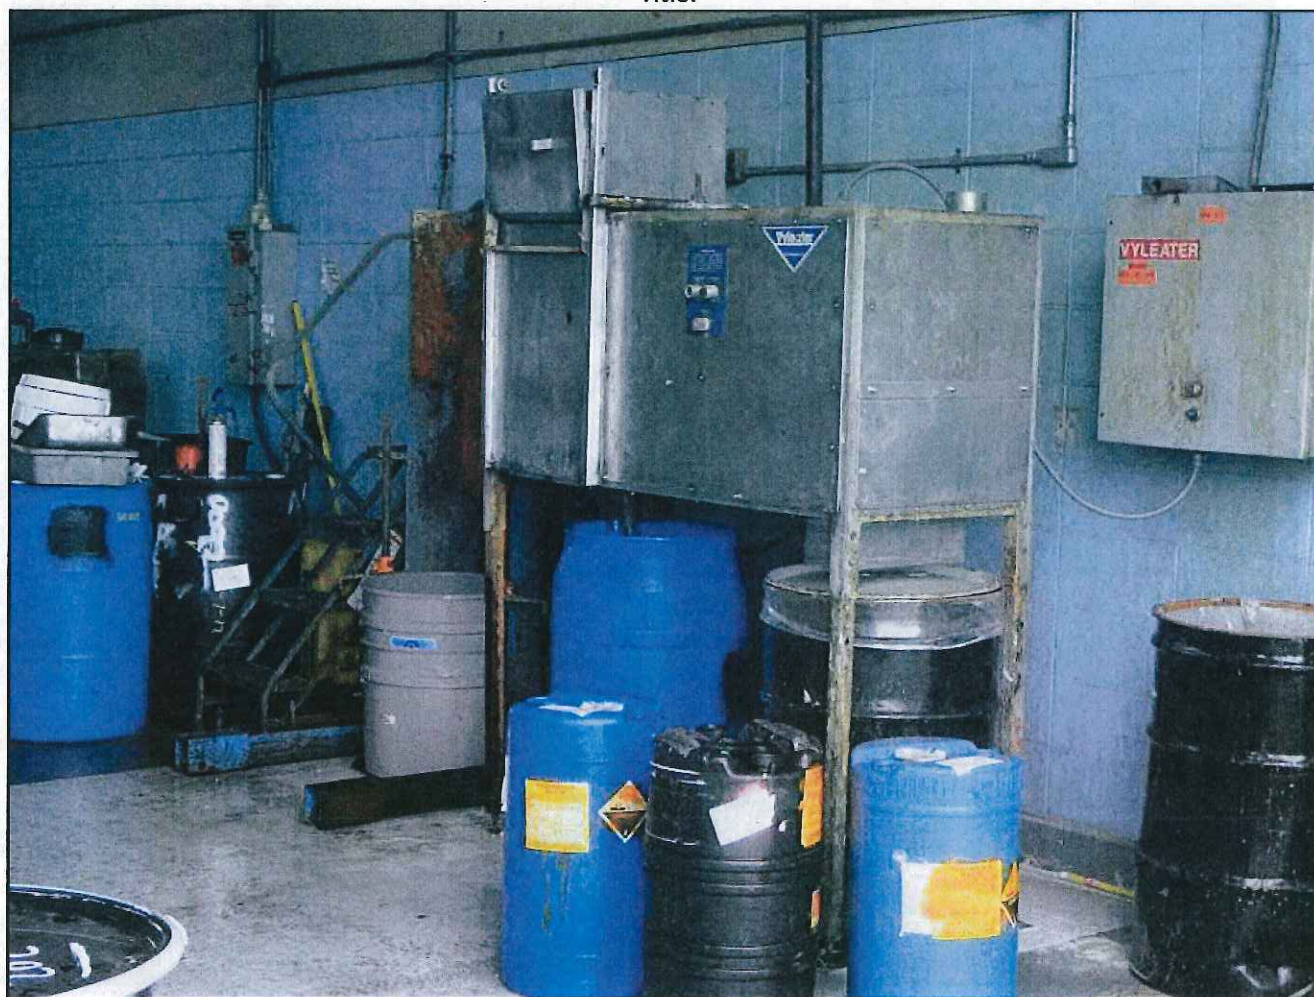
File Name	RIMG0071.JPG
Date Time Stamp	7/20/2012 11:20:21 AM
Photographer:	A. Ruhs
Latitude	N 39° 44' 49"
Longitude	W 86° 18' 04"
Photo Direction	43° NE
Description:	mercury vial crusher and washer at the mercury processing area. Blue drum collects the mercury and rinse water to process, and the black drum collects the vials.
